**LAWTON VALLEY RESERVOIR DAM
RI 02701**

**PHASE 1 INSPECTION REPORT
NATIONAL DAM INSPECTION PROGRAM**

**DEPARTMENT OF THE ARMY
NEW ENGLAND DIVISION, CORPS OF ENGINEERS
WALTHAM, MASS.**

MARCH 1980

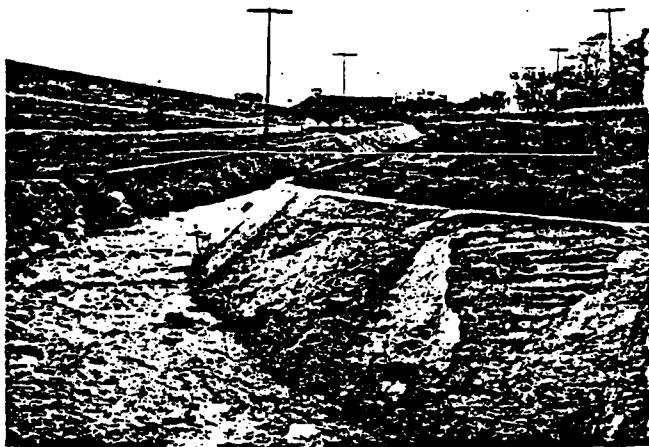
VIEW LOOKING SOUTH UP OUTLET CHANNEL.

NOTE: SPALLING CONCRETE AND VEGETATION IN SEAMS.

The concrete spillway is in excellent condition. However, the concrete-lined outlet channel shows evidence of spalling and some vegetative growth along seams (see attached photograph #3)

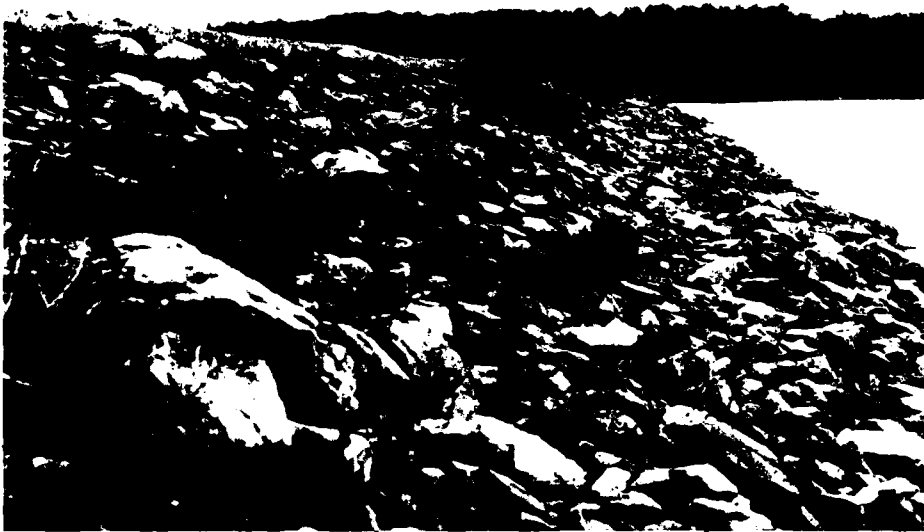
1. Upstream Slope - The upstream slope is covered with riprap up to the crest. The overall condition of the riprap is good, although some slumping of the riprap has occurred in several locations. Apparent downslope movement of the riprap has exposed the underlying gravel base in some areas. Slumping of the riprap and erosion of the underlying material have occurred along the upstream edge of the crest in several locations. Crushed stone and additional riprap have been placed near the crest on the upstream slope in several locations, apparently to repair areas where slumping and erosion have occurred. (See photos C-1, 2.)

. PHOTO C-1 Upstream face of dam looking toward right abutment.

- a. Operations and Maintenance Procedures.
 1. The erosion and slumping of riprap that have occurred on the upstream slope should be repaired.
 2. The undermining of the upstream edge of the concrete pad on the upstream slope should be repaired.
 3. The brush growing on the upstream slope between Sta 21+00 and the right abutment should be cleared.

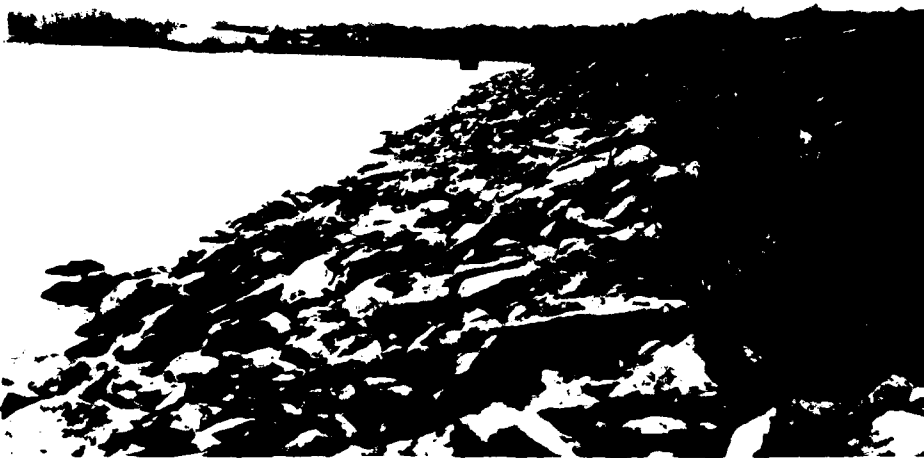
. PHOTO C-2 Upstream face of dam looking toward left abutment.

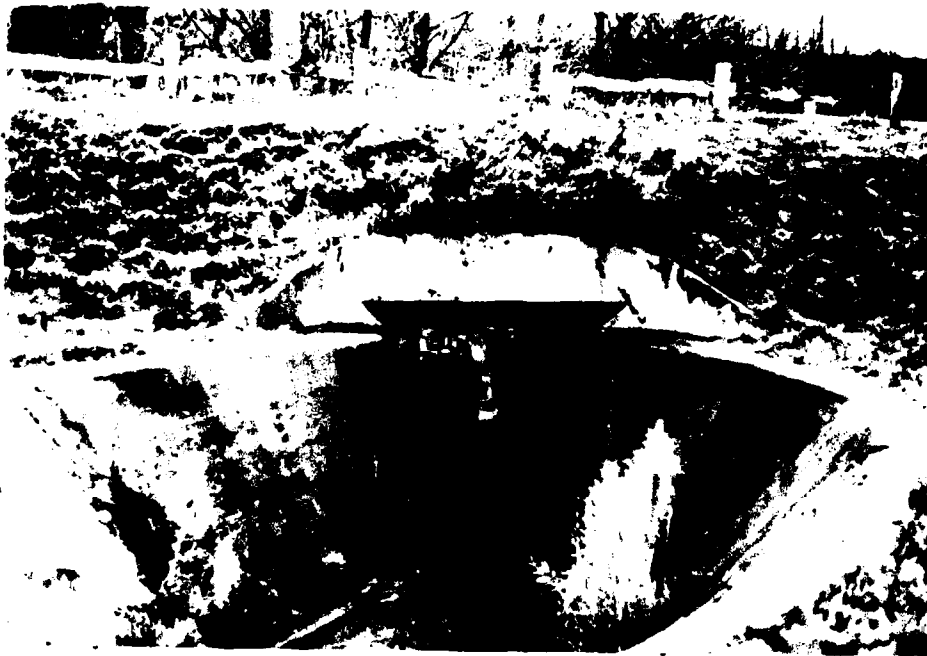
1. Spillway - The upstream spillway channel is unlined, and there is some brush growing in the floor of the channel. The spillway weir and training walls are concrete. The downstream spillway channel consists of a concrete lined sluiceway. The concrete lining of the sluiceway is spalled badly in several locations, and small brush is growing in the seams. Weep holes are located in the sluiceway walls; none were discharging at the time of inspection. A number of depressions were observed in the soil, averaging 2 to 4 inches in diameter and up to 6 inches in depth, randomly located behind the sluiceway channel walls. (See photos C-8, 9, 10, 11, 12, 13)

• PHOTO C-11 Box culvert at downstream end of spillway chute.

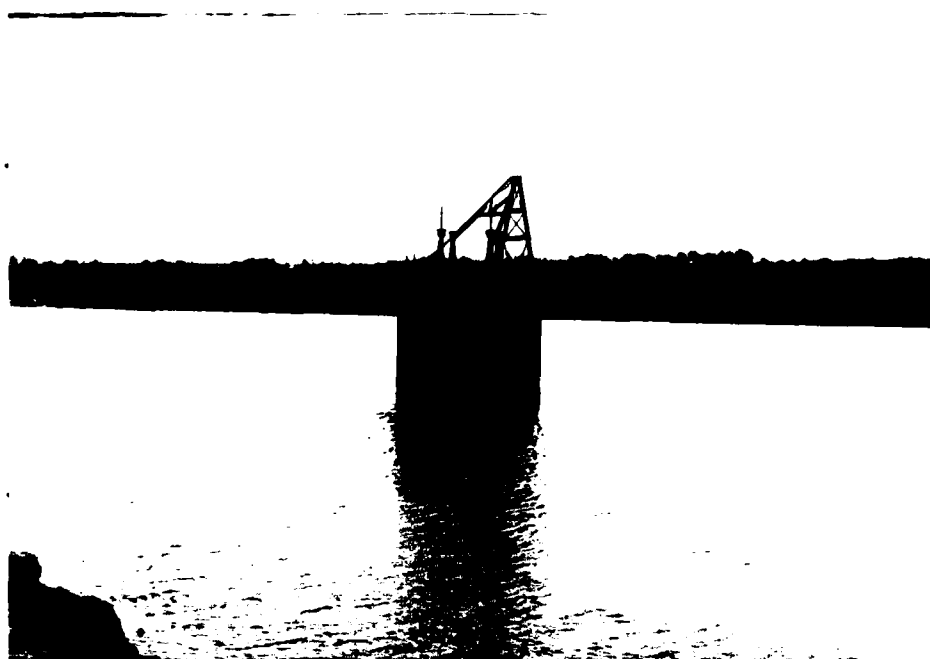
2. Outlet Works - The outlet works consists of a reinforced concrete intake tower at the upstream toe of the dam, a 30-inch concrete conduit through the embankment, and an outlet chamber at the downstream toe. Inspection of the tower was limited to observation from the crest of the dam, only. The gate mechanisms were operating and were reportedly in good working order, and the concrete work above the waterline appeared to be in good condition. Since the outlet conduit and the outlet chamber were through the embankment and underground, they were not accessible for inspection. The 18-inch diameter blow-off pipe leads from the underground outlet chamber to the open channel of the overflow spillway. (See photo C-13.) Leakage and cracks were observed in the 30-inch diameter concrete conduit in 1979 as the result of daily inspections by operating personnel. This was reportedly repaired by concrete lining of the conduit. (See photos C-6, 7)

· PHOTO C-6 Intake chamber and control tower.
